UNIVERSITY OF CALIFORNIA, RIVERSIDE

STATISTICS-COMPUTER BUILDING HVAC STUDY

FINAL REPORT

April 2008

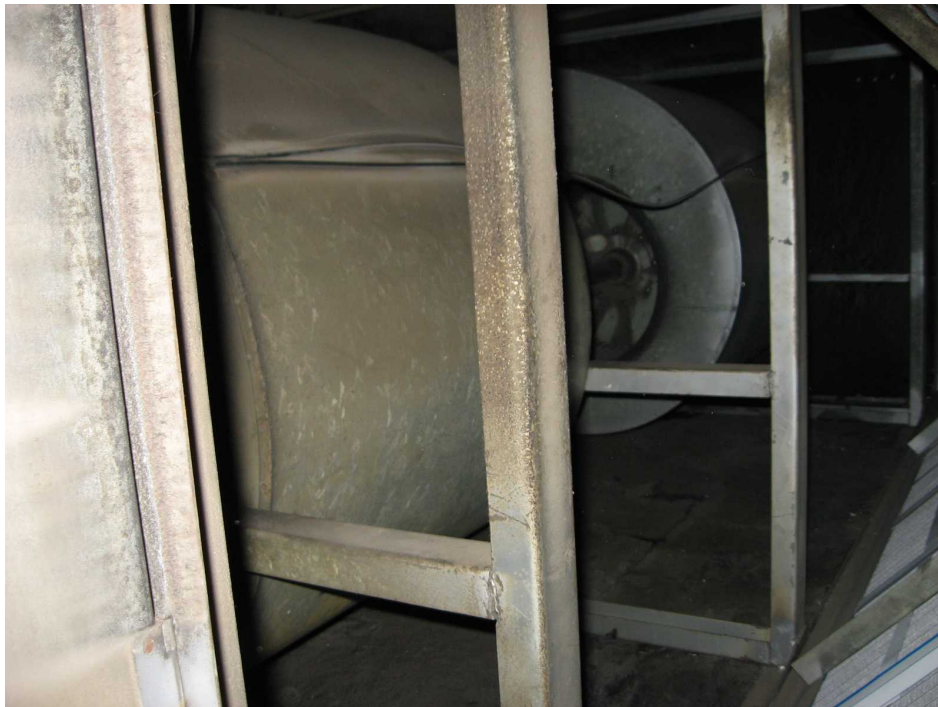
Figure 3-1: Existing Supply Fans in AH-2

The supply fans are squirrel cage type, belt driven, forward curved, and double inlet dual fans. For AH-1, AH-2, and AH-3, fan motors are mounted outside the unit while for AH-4, the motor is internal. The fans appear to be in poor condition. **Figure 3-1** below shows the old dusty dual squirrel cage fans in AH-2.

The fact that the motors were mounted outside the air stream eliminates motor heat gains to the airflow, but increases air leakage through the fan shaft penetrations at the AHU casing.

- **Option 1 - Replace existing coils and fans only with new.** New fans are proposed to be more energy efficient and have larger airflow capacity. The fan motors are proposed to be installed inside the air handling units to prevent air leakage through fan shaft penetrations. With new cooling and heating coils, the heat transfer will be improved and the coil leaving air temperature can be maintained at the desired range. As the existing unit casings are very old and leaking air, **GEI does not recommend this option.** This option is presented here is to show this as a basis for option comparison purposes.

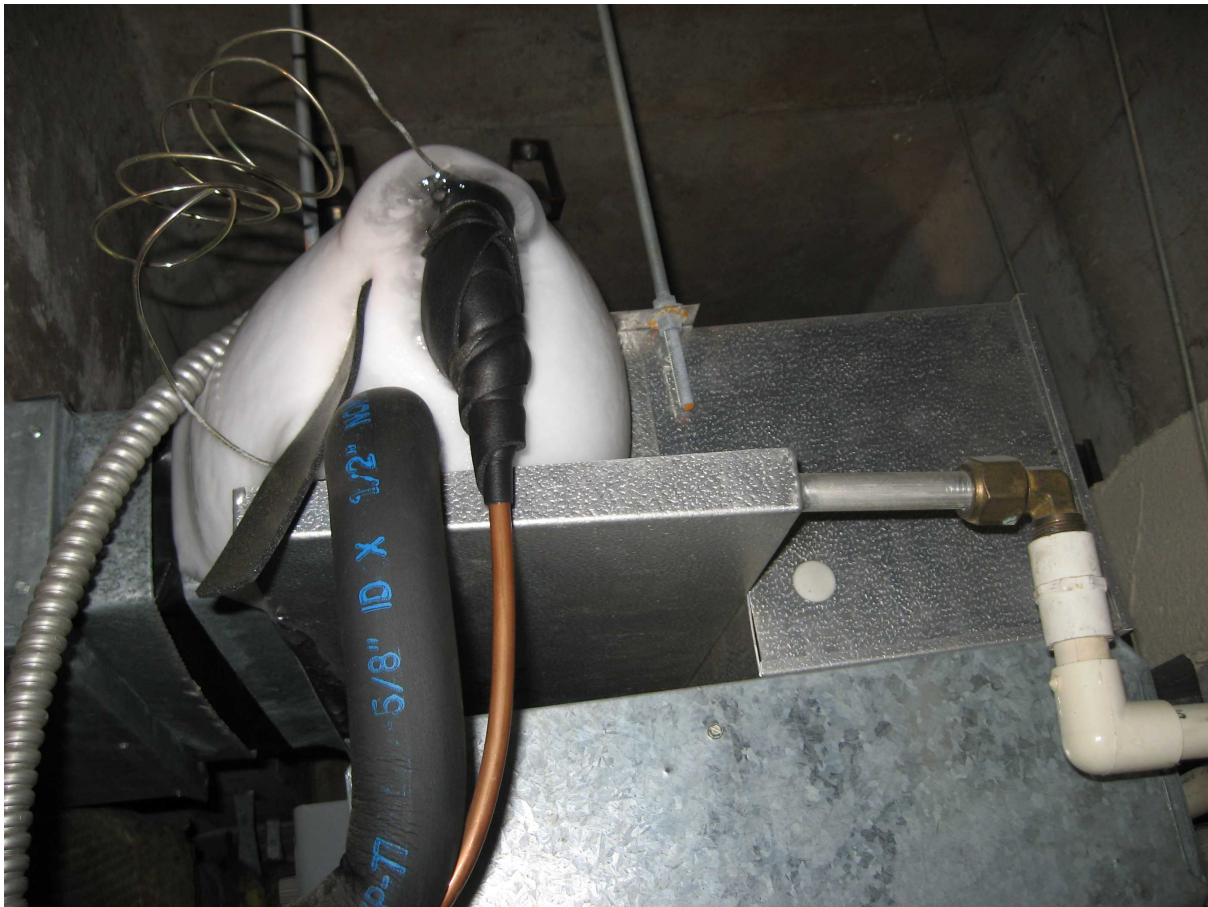
Figure 3-9: Ice block at Fan Coil Unit FCU-1 in Room 2690

These fan-units supplied no air to the room when the room temperature was as high as 86 degree F during GEI's field investigation. A huge ice block was found at the fan-coil unit above the ceiling as shown in **Figure 3-9** below.

Failed DX Split Systems Three direct expansion split systems currently serving Room 2686 and 2690 (computer labs) are not working properly. These units are in very bad condition and appear to be in already-failed condition. The dedicated space temperature sensors (not the wall mounted pneumatic thermostats which control zone dampers), which are installed in the house-air ceiling return grilles, fail to energize the split system for cooling causing the room temperature to reach as high as 85 degree F.

The existing three DX split systems are not working properly. GEI proposed to replace the three units with new chilled water units with the cooling capacity to meet the current load. When larger delta-T cooling coils are installed to replace the existing coils in the AHUs, less chilled waterflow (in gpm) is required and therefore, existing pipe size is adequate.
